Modelling a Backdraft Incident

The 62 Watts St (NY) Fire

by Richard W. Bukowski P.E.

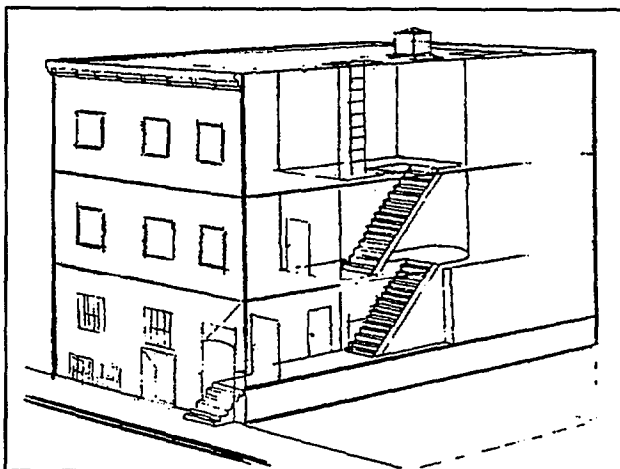
Figure 1. 62 Watts St.

The fire occurred in a three story, multiple brick dwelling of ordinary construction approximately 6.1 m (20 ft.) wide by 14 m (46 ft.) deep, and 3½ stories tall. The building contained four apartments, one on each storey, with the basement apartment half below grade. While the basement apartment had its own entrance, access to the others was by an enclosed stairway running up the side of the building. The building was attached to an identical building (64 Watts St.) which was not involved.

The buildings were built in the late 1800s and had undergone many alterations over the years. Recent renovations included replacement of the plaster/lathe with drywall on wood studs, lowering the ceilings to 2.5m (8.25 ft.), new windows and doors, heavy thermal insulation, sealing and caulking to minimize air infiltration (the building was described as very tight). Built before central heating, the apartments had numerous fireplaces, most of which had been sealed. The apartment of fire origin had two fireplaces, but only the one in the living room was operable. All apartments had thick plank wood floors.

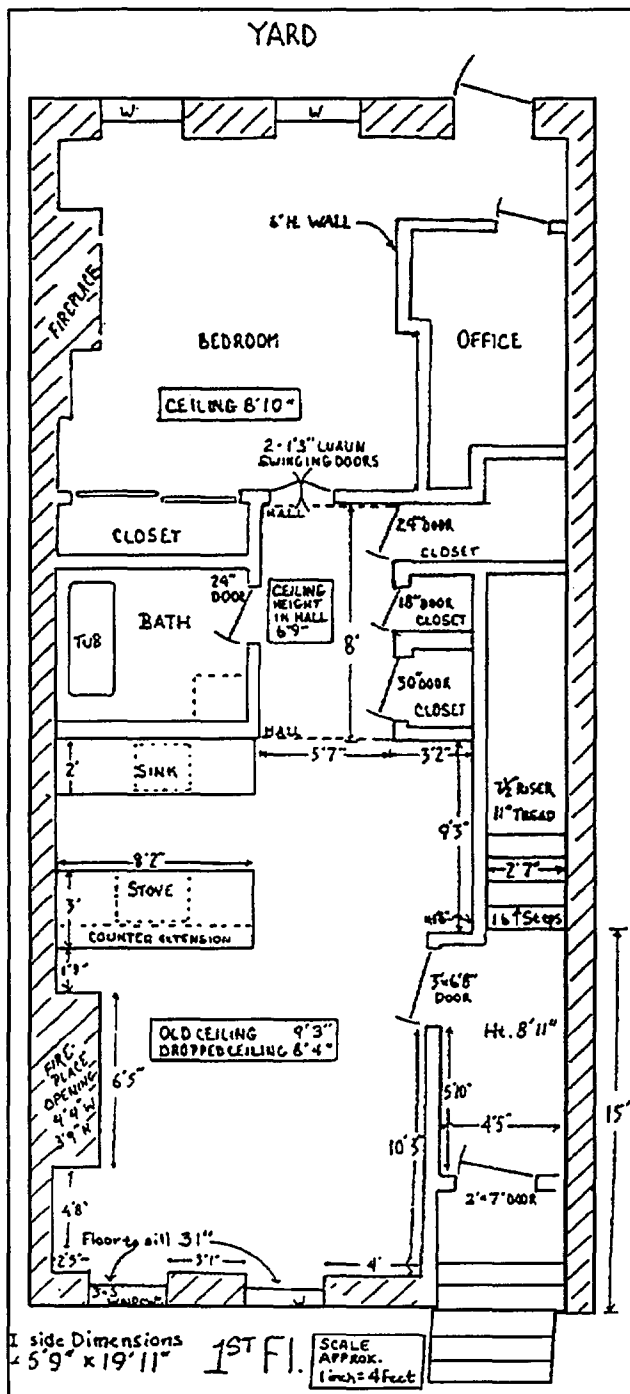
Figure 2. First floor apartment.

The apartments had similar floorplans; the differences resulting from the stairway. A floorplan of the first floor apartment is presented in Figure 2. There was a living room in the front, kitchen and bathroom in the center, and a bedroom in the rear. The first floor apartment had an office within the bedroom which was not found in the other apartments, but which was not significant in the fire. The roof had a scuttle for access and a wired glass skylight located over the stairway.

Damage to the apartment of origin was limited to the living room, kitchen and hall – closed doors prevented fire spread to the bedroom, bath, office, and closets. There was no fire extension to the other apartments and no structural damage. The wired glass in the skylight was melted in long “icicles” and the wooden stairs were mostly consumed. The description provided by the surviving hose team was of a classic backdraft; but these usually persist only seconds before exhausting their fuel supply. Where did the fuel come from to feed this flame for so long?

off. It is reasonable that the pilot light ignited the bag, which then involved several bottles of high alcohol content liquor on the counter, and spread the fire to the wood floor and other contents. The occupant confirmed that all doors and windows were closed, so that the only source of combustion air was the fireplace flue in the living room from which the smoke and sparks were seen to emerge.

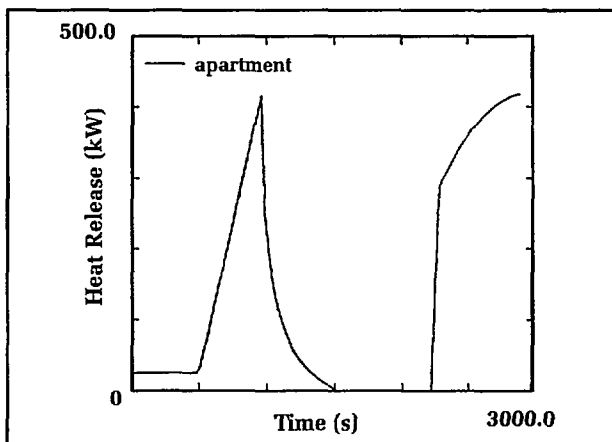
Figure 3. HRR in apartment.

The initial fire was assumed to be a constant heat release rate (HRR) of 25 kW from actual data on burning trash bags [3]. This fire then transitioned into a “medium t²” fire with a peak heat release rate of 1MW (Figure 3);

however this was never reached due to limited oxygen. Such “medium t²” fires are characteristic of most common items of residential contents [4].

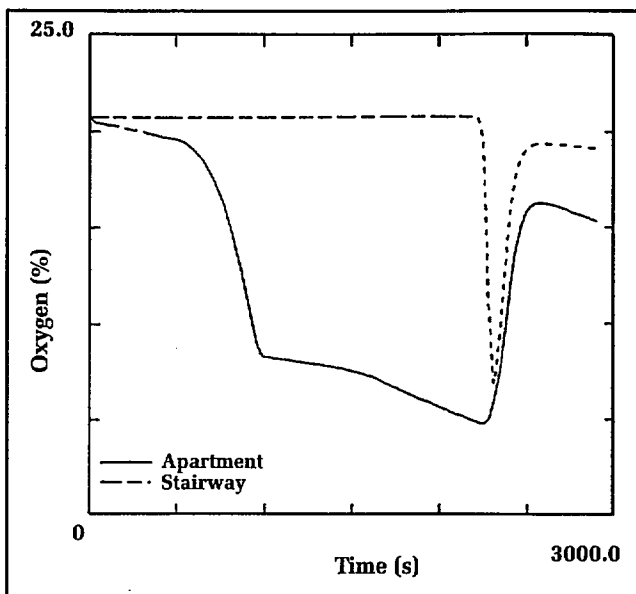
Figure 4. Oxygen concentrations.

about 500 kW over 5 minutes of simulation time, then rapidly throttled back as the oxygen concentration dropped below 10% (Figure 4). Temperatures in the apartment peaked briefly at about 300°C (570°F) at the time of peak burning, then rapidly dropped below 100°C (200°F) as the burning rate fell (Figure 5). The concentration of carbon monoxide (CO) rose to about 3000 ppm and unburned fuel accumulated within the apartment volume during this stage of vitiated combustion.

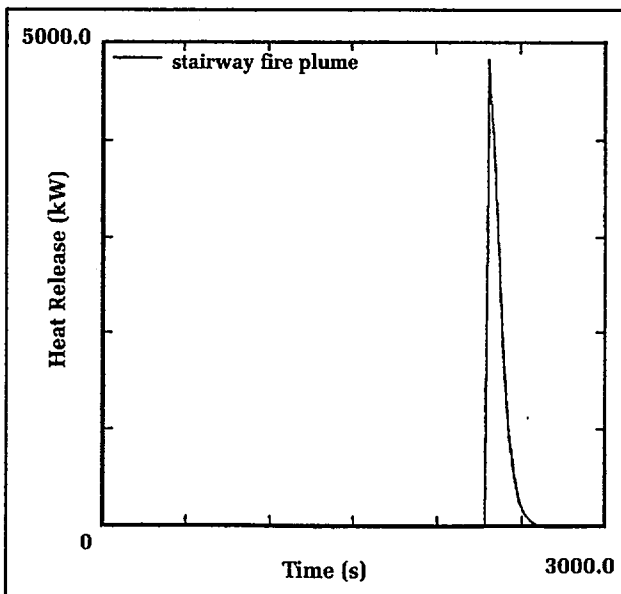
Figure 6 Upper temperatures.

The front door was opened at 2250 seconds into the simulation as an estimate of when the first floor team made entry. Immediately, there was an outflow of warm (100°C) air from the upper part of the doorway, followed by an inrush of ambient air in the lower part of the doorway, followed by the emergence of a large door flame — exactly as reported by the firefighters. This door flame grew within a few seconds to a peak burning rate of nearly 5 MW (Figure 6), raising the temperature in the stairway to over 1200°C (2200°F) (Figure 5) sufficient to melt the glass in the skylight, as observed. Most importantly, the quantity of unburned fuel accumulated in the apartment caused the door flame to persist for more than 7 minutes (Figure 6).
